## The Analysis on Ground Treatment Methods Used in East Coast Rail Link (ECRL) Project, Section 6 Maran

DOI: <https://doi.org/10.30880/peat.2024.05.02.069>

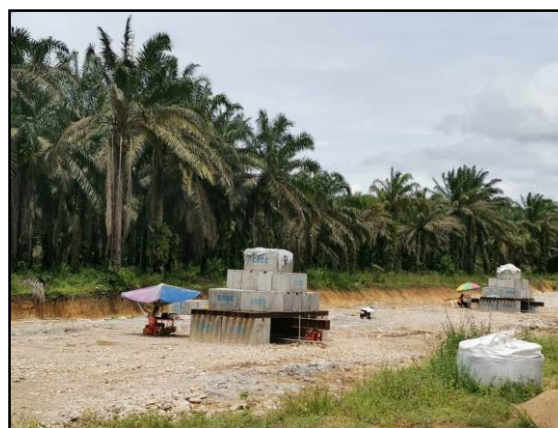
A test pit is excavated to the desired depth, typically at the level of the improved soil layer, and a rigid steel plate is placed on the soil surface. Incremental loads are applied to the plate using a hydraulic jack, and the settlement of the plate is measured at each load increment using precision instruments like dial gauges. The load-settlement curve is then plotted, and the ultimate bearing capacity and modulus of subgrade reaction are determined in figure 2 show the placement of the plate load.

**Fig. 2** placement of plate load

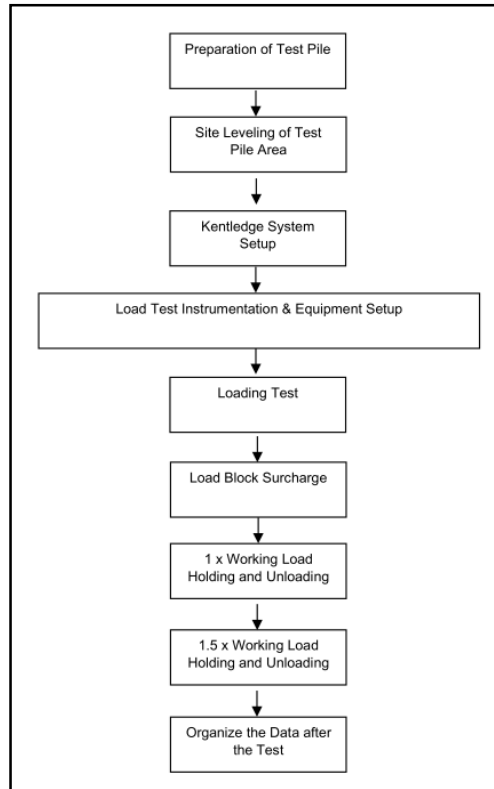
This test provides a direct measurement of the improved soil properties, allowing for validation of design assumptions and confirmation of the DSM treatment's effectiveness. It's essential to ensure proper curing time before testing and to conduct multiple tests across different locations to account for variability in soil conditions and mixing effectiveness. Based on figure 3 display flowchart for plate load test work sequence.

**Fig. 3** flowchart for plate load test work sequence.

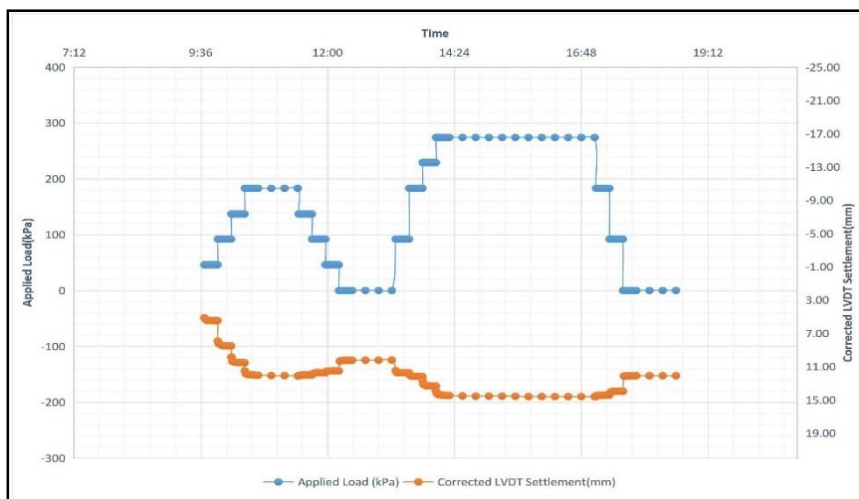
Figure 4 show the corrected displacement over elapsed time for LVDT of plate in cycle 1 and cycle 2. In Cycle 1, the process begins with a series of incremental increases in load, starting at 25% with a corresponding pressure of 46 kPa. At this initial load, the settlement observed is around 5.48 mm. As the load is progressively increased, moving to 50% (92 kPa) and 75% (137 kPa), the settlement continues to increase correspondingly. When the load reaches 100% (183 kPa), the settlement measures approximately 12.12 mm. In Cycle 2, the process once again involves incremental increases in load, but starting at a higher initial percentage compared to Cycle 1. The cycle begins at 50% with a pressure of 92 kPa, then progresses to 100% (183 kPa), 125% (229 kPa), and finally reaches a peak load of 150% (274 kPa). As the load increases, the settlement also increases in a corresponding manner. By the time the load reaches 150%, the settlement reaches about 14.61 mm.

**Fig. 4** The corrected displacement over elapsed time for LVDT of plate in cycle 1 and cycle 2

The displacements at the plate were monitored by 4 numbers of LVDTs. The corrected displacement of these LVDTs is summarized in Table 1 respectively. Figure 4 plots the corrected displacements of plate and loading sequences over elapsed time. Figure 5 plots the displacement of pile top corresponding to each applied load. In Cycle 1, the maximum load at 100% of WL (i.e. approximate 183kPa), the maximum displacement at plate registers at **12.12mm**, did not exceed the 25mm required by the specification. Upon completion of unloading, the plate

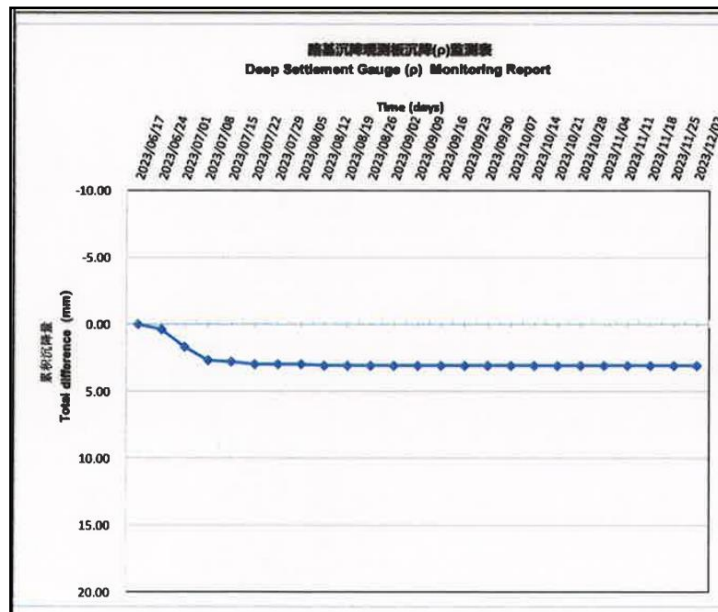
Figure 6 From graph we can analyse that for the deep settlement gauge the settlement reach constant stage is at day 56 until day 168. The total settlement end at 3.1mm. from this graph we can conclude that centre part of the PVD area have the least water content.

**Fig. 6** Graph for deep settlement gauge monitoring report for the chainage 314+112 centre part

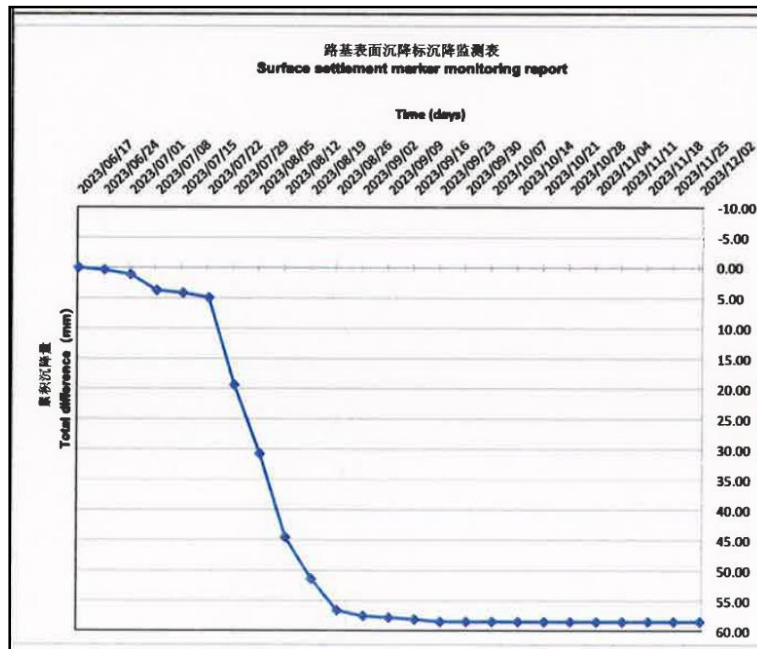
Based on table 5 the surface settlement gauge for monitoring report for the chainage 314+112 left part where it shows how many days and the total settlement for the PVD method. Figure 7 show surface settlement gauge monitoring report for the Chainage 314+112 left part. In this figure it shows the left part a massive drop from 5.0mm to 58.2mm and then stay constant 58.6mm it shows that the left part has more water content than the centre part.

Fig. 7 Surface settlement for gauge monitoring report for the Chainage 314+112 left part.

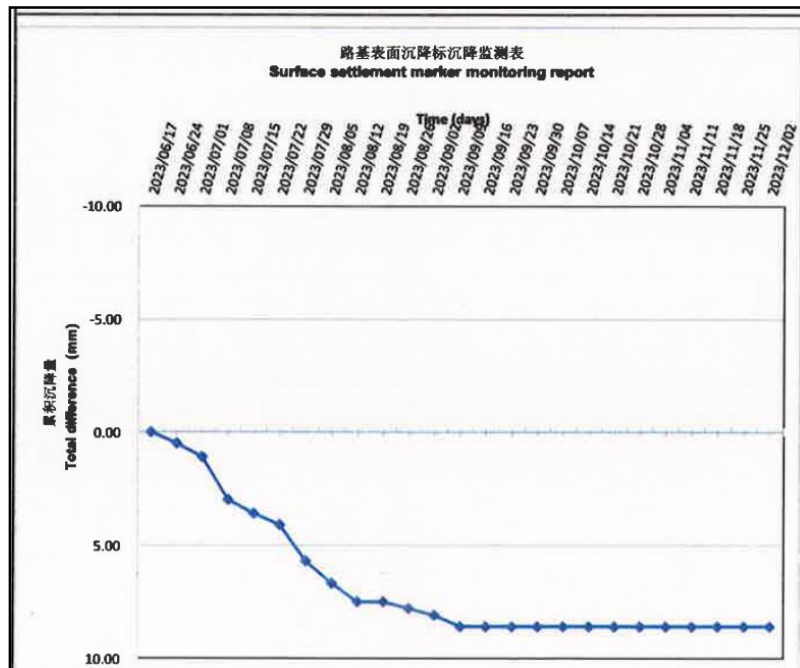
Figure 8 the graph effectively illustrates the settlement behaviour of the ground at Chainage 314+112 Right part over the monitoring period. The initial rapid settlement followed by stabilization suggests that the ground conditions have normalized, which is a positive outcome for construction activities. This type of monitoring is essential for ensuring the safety and stability of engineering projects

Fig 8 Show surface settlement gauge monitoring report for the Chainage 314+112 right part

Table 6 show surface settlement gauge monitoring report for the Chainage 314+112 right part. In this table it shows the right part a significant drop from 0.5mm and end at 8.6mm and then stay constant 8.6mm suggesting that the soil has reached a stable state by the end of the monitoring period.
